RARITAN RIVER BASIN
MILLSTONE RIVER
MERCER COUNTY
NEW JERSEY

CARNEGIE LAKE DAM

NJ 00150

PHASE 1 INSPECTION REPORT
NATIONAL DAM SAFETY PROGRAM

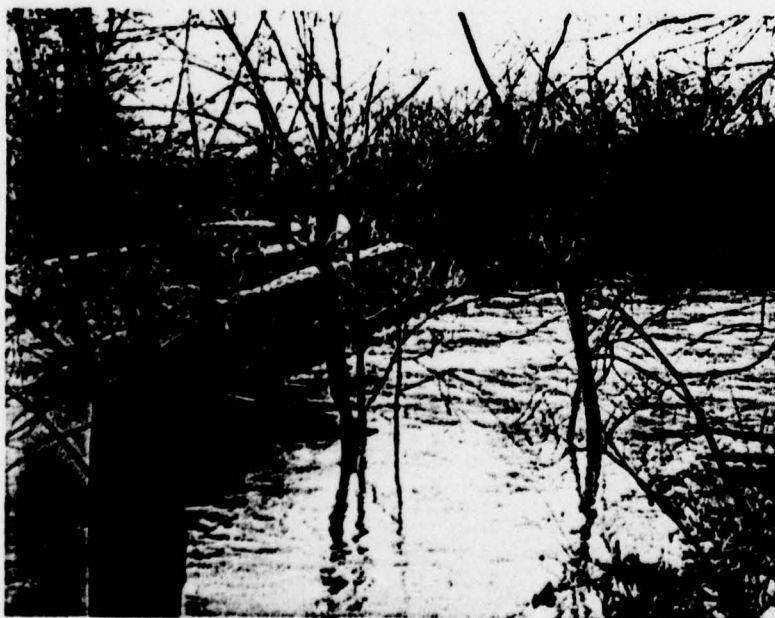
Kingston bridge after heavy rainstorm

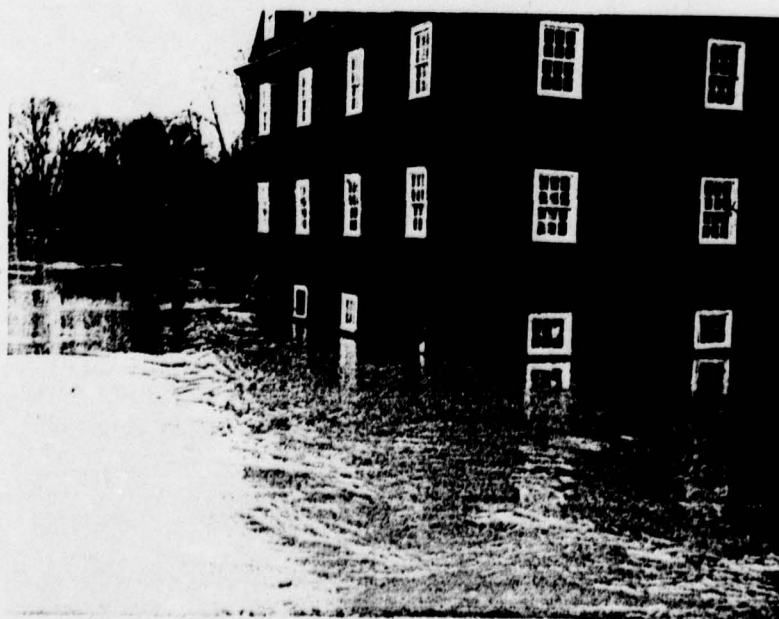
View after heavy rainstorm
